EFFECTS OF TRADITIONAL INSULATION SYSTEMS

SIMPLE SAVER SYSTEM® VS. TRADITIONAL METHODS OF INSTALLATION

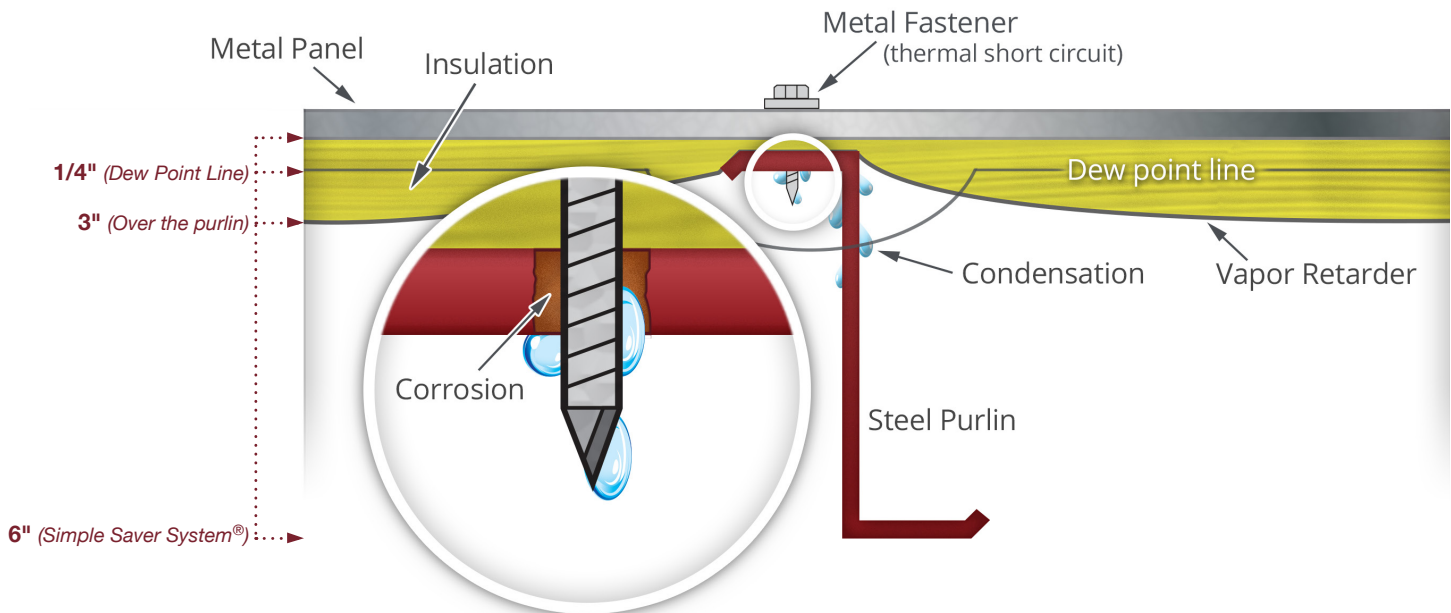
MAJOR DEFECTS

- Improper placement of vapor retarder (over the purlin)
- Severe loss of insulation value from compression

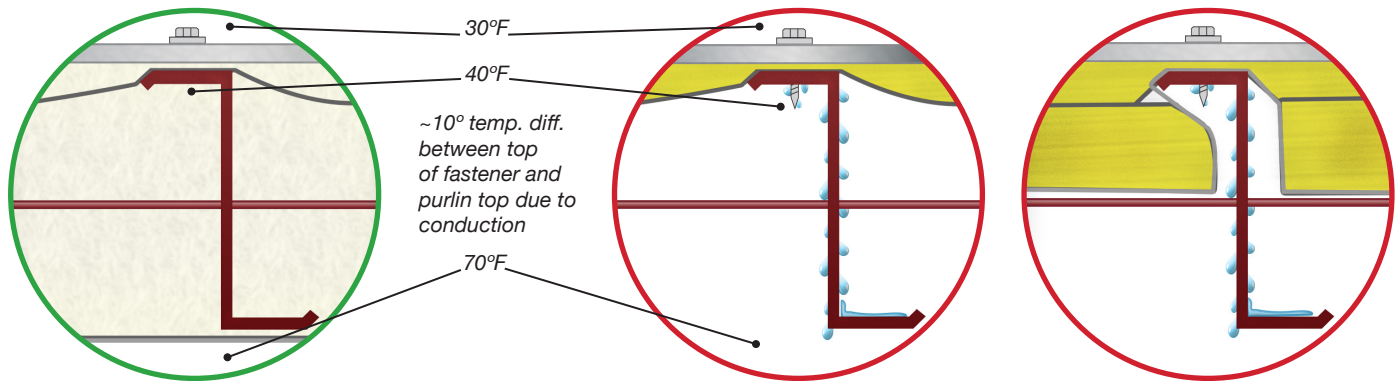
SIMPLE SAVER SYSTEM®

- Thick Insulation
- Proper Vapor Retarder Placement
- Purlins Fully Encapsulated
- Attractive Appearance
- Extrusion Welded Seams

OVER-THE-PURLIN METHOD

- Severely Compressed Insulation
- Defective Vapor Retarder Placement
- Exposed Conductive Structure
- Unfinished Appearance
- Poorly Sealed Seams

LONG TAB METHOD

- Compressed Insulation
- Defective Vapor Retarder Placement
- Voids in Insulation
- Exposed Conductive Structure
- Unfinished Appearance
- Poorly Sealed Seams
